A GEOTECHNICAL NOTE ON THE FAILURE OF NORTHWESTERN PART OF BAHU FORT DURING RECENT RAINS, JAMMU DISTRICT, J&K

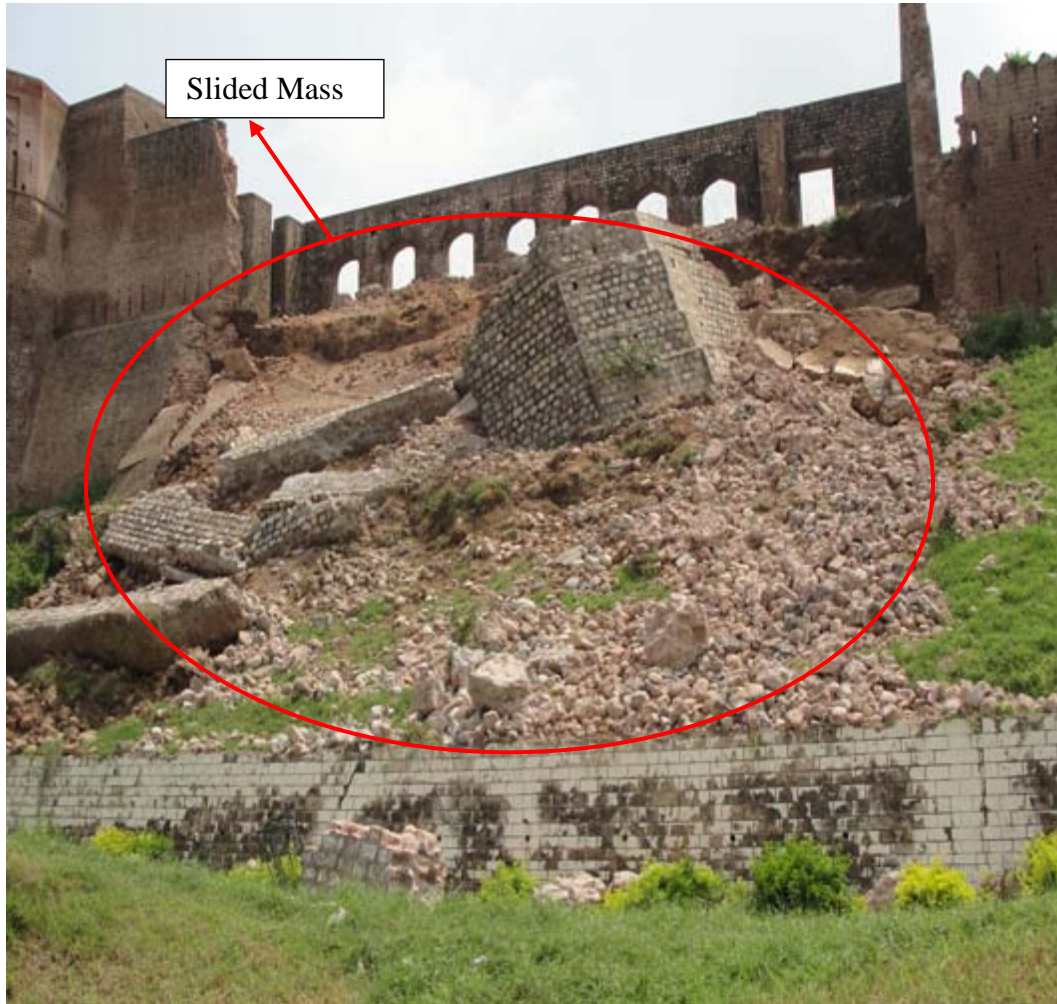
(Fig.no-1)

The northwestern part of the fort area which has been collapsed is mainly located on unconsolidated boulder bed (Photo-1). This boulder bed is characterised by well rounded boulders, cobbles, pebbles of predominantly quartzite, sandstone, siltstone, granite gneiss and basic volcanics embedded in sandy clayey matrix.

The fallen part of the fort appears to have renovated by concerned authorities in the near past which is evident from the rubble of the damaged wall which consists of cement concrete along with boulder/block of quartzites. The main causative factor of collapse seems to be the overloading of concrete masonry wall which has subsequently deteriorated because of over saturation of the foundation material due to long spell of heavy rains. Besides, due to improper drainage system within the fort premises, the rain water would have percolated in the foundation material resulting into foundation settlement.

In view of the above observations, it is strongly advised that **i)** the damaged concrete masonry wall should be off loaded immediately and the affected slope area should be left as such with deep rooted plantation, **ii)** Rebuilding of any type of protection wall should be totally avoided, **iii)** The floors of the fort area (Photo-2&3) which is presently covered by grass and debris material should be removed and adequate

flooring work should be done to prevent any seepage towards valley side **iv)** Proper drainage arrangements in and around floors of the fort area should be made to divert rain water towards the southern slopes of the fort with proper lining **v)** the damaged toe part of original fort wall may be repaired manually with masonry work only.
